**CONCRETE**  
**cfa FOUNDATIONS**  
**ASSOCIATION**

CFA-TN-010

## Waterproofing, Drainage and Maintenance

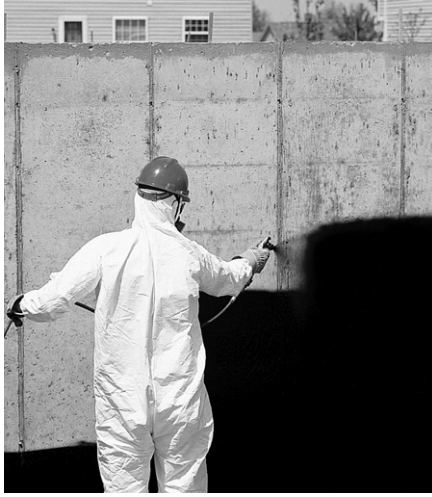
**Fig. 4:** Spray-emulsion waterproof coating applied to a concrete foundation wall.

Waterproofing is required when the foundation walls enclose a habitable or other usable space and the area is subject to a high water table or other ground-water conditions. It should completely cover the walls that are below grade and extend from the top of the footing to the finished grade (see **Fig. 4**).
